Analysis of Barriers

Transportation Assets and Barriers | 3. Analysis of Barriers

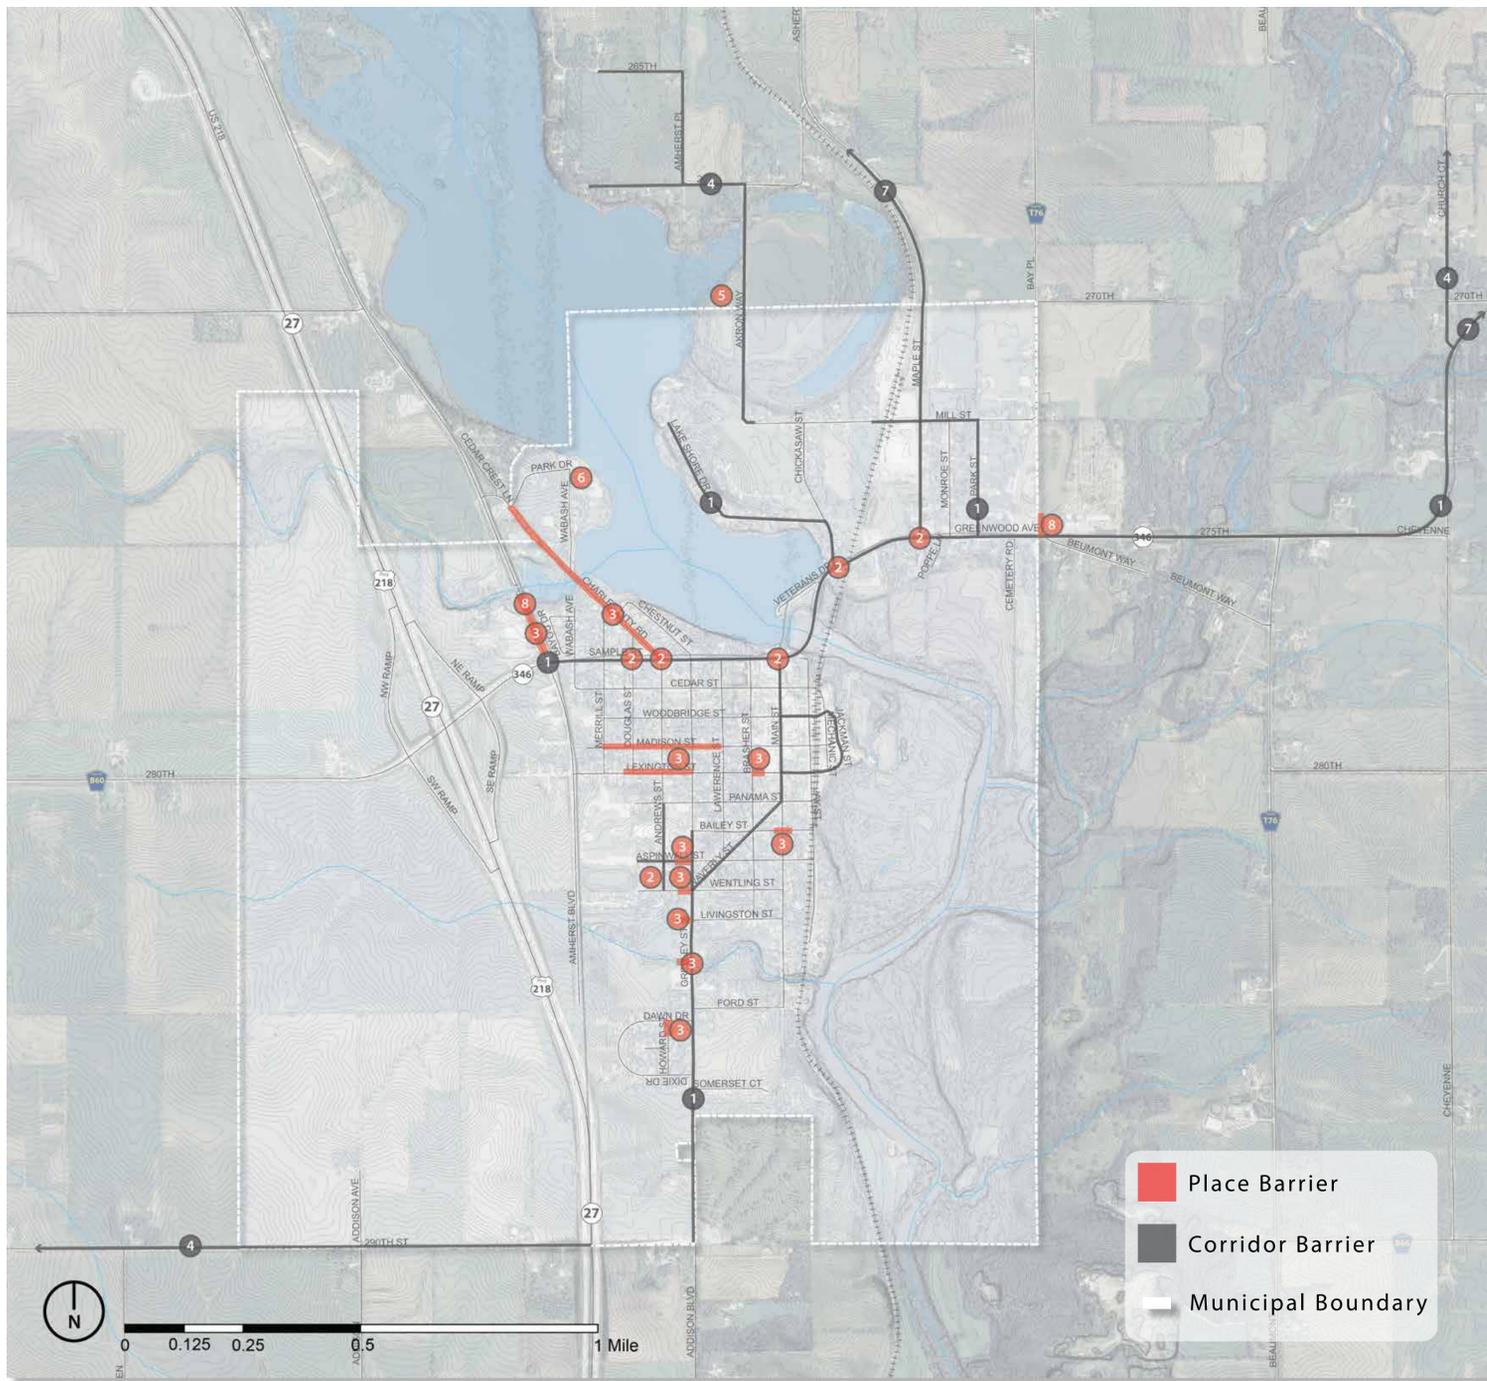
The most pervasive barrier in Nashua is **lack of continuous sidewalks (1)**, particularly along Highway 346, Greeley/Addison Boulevard, and Main Street/Diagonal area. Currently, youth and active recreation users trying to access the lakefront parks or open spaces east of town such as the fairgrounds must travel on the edge of Highway 346. Adult runners and the high-school track team use the existing partial sidewalks on 346 as a primary route. They fear being struck by a driver because of blind curves, weather conditions, and high traffic speeds. They note that there are no safer places to run that have the desired distance.

Congestion and speeding traffic affect transportation use (2). Children walking to school are present at commuting times, a worry for parents whose children must cross primary vehicular routes. Active adults, teenagers, and parents all noted higher speed traffic on 346 and on Main Street, as well as congestion near the high school and near the bridge. Seasonally heavy truck traffic that circles the co-op east of Main Street creates an intimidating barrier for pedestrians and cyclists. The impact of congestion and traffic speed could be mitigated, participants said, by having clearly marked crossings and clearly defined continuous sidewalks. Participants want crosswalks at several locations, including near Subway and the welcome center, at the Dairy Treat, and at Chickasaw and 346.

Seasonal moisture and dryness interrupts travel. Wet and wintery conditions and dust from gravel roads complicate travel—especially pedestrians and cyclists. **Water and slush flood areas (3)** around Sample Street (Hwy 346), forcing pedestrians onto roads or into yards. On Charles City Road and Amherst Blvd, seasonal wetness and **snow drifting (8)** interrupt recreational travel to the welcome center and the lake. North of the high school, flooding on Madison and Washington

Recreation users and lakeside residents report that **dust from gravel roads stirred up by traffic in summer drifts onto trails and into campgrounds (4)**, making breathing difficult. Those who run and cycle on gravel for exercise also note dust as a problem. Recreation users and many other participants **would like to see a long distance trail (7)** developed to connect destinations such as Charles City (on Maple Street) and Waverly and Denver (along Hwy 346).

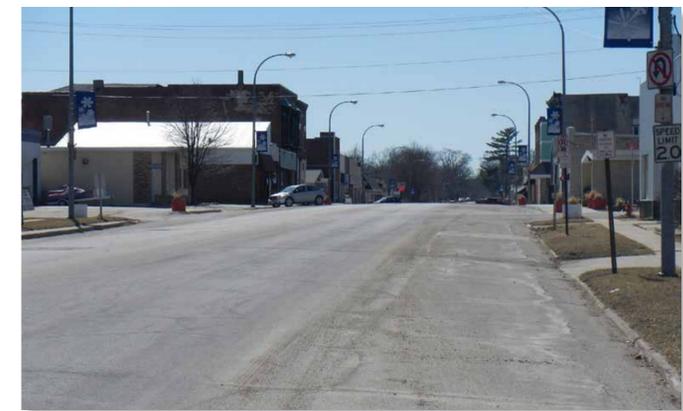
No stop signs on main street
